Firmware NEXUS_01_16_00.8 is available

For HP Latex 3x0 Printer Series

October 2019

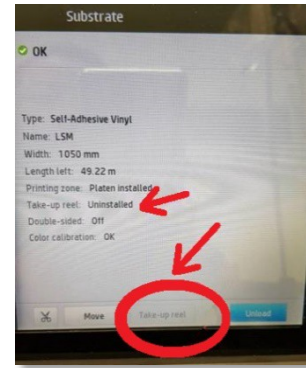
Fix for the Take-up Reel button grayed out in the Front Panel menu after Firmware upgrade

There was a known issue which mainly appeared after upgrading the firmware to the previous version (NEXUS_03_14_00.8). The Take-up Reel button on the Front Panel became grayed out, inaccessible.

This firmware permanently solves the issue with the Take-up Reel button on the Front Panel becoming inaccessible.
