# Release Notes: Version G.07.50 Operating System

## *for the HP ProCurve Series 4100GL Switches*

5990-3067  
November 2003  
Edition 4

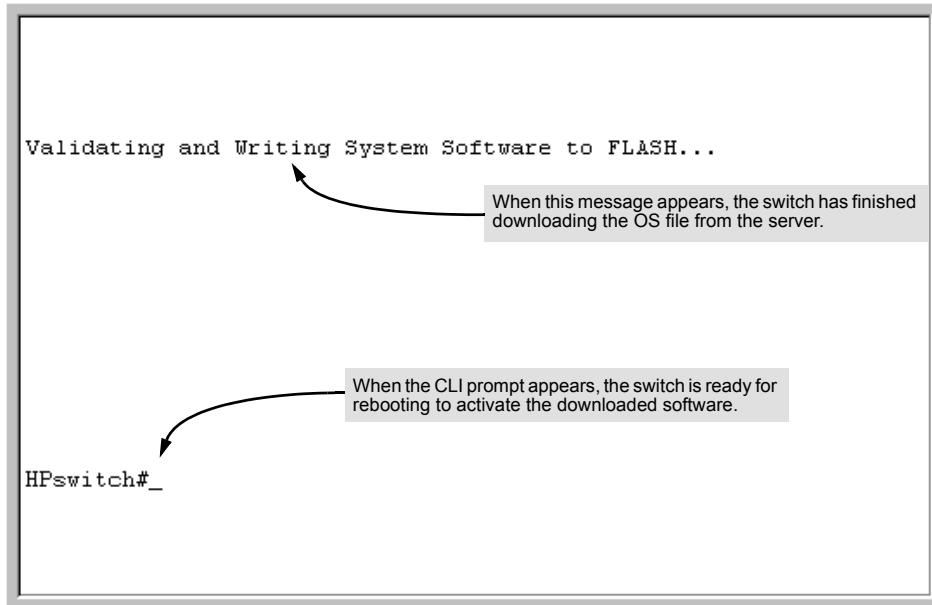
2. When the switch finishes downloading the OS file from the server, it displays the progress message shown in [figure 1](#). When the CLI prompt re-appears, the switch is ready to reboot to activate the downloaded software:

**Figure 1. Message Indicating the Switch Is Ready To Activate the Downloaded Software**
