# Firmware Release Note

| <b>Model: K2200 Series</b> | <b>Date: 29-Jun-2016</b> |

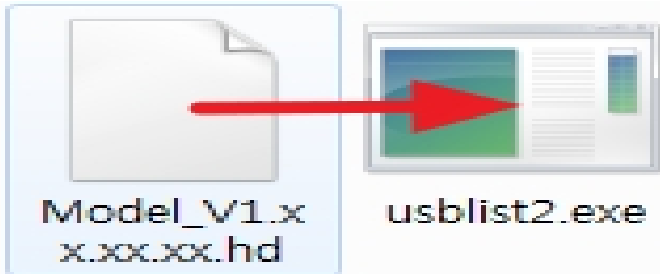
- 1) Make sure that the machine is connected to the PC with a USB cable.
- 2) Drag the firmware file(\*.hd) and Drop down it on usblast2.exe.  
And then firmware update will be started automatically.

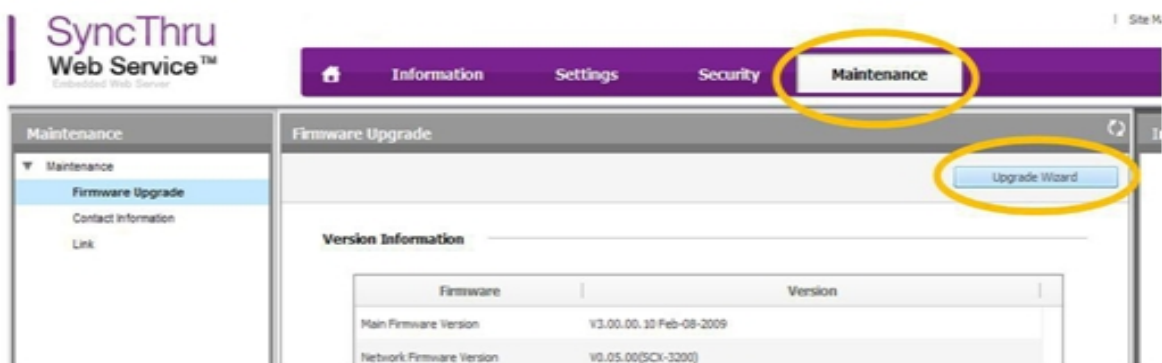
- 2) Click 'Login' on the upper right of the SyncThru Web Service.  
And log-in as an administrator.  
(Default ID : admin PW: sec00000)  
※ We recommend you to change the default password for security reasons.
- 3) 'Maintenance'→'Upgrade Wizard' → 'Browse'  
And, Select the firmware file and click 'Next'
